THE FURNACE RESTORATION PROJECT

The Oswego Iron Furnace was the first furnace on the West Coast and is the only surviving charcoal iron furnace west of the Rocky Mountains. Since 2003 the Oswego Heritage Council has worked closely with the City of Lake Oswego to create a restoration plan for the 1866 structure, which stands in a city park on the banks of the Willamette River. Although the buildings that originally surrounded the furnace are gone, the riverside site and the creek that provided waterpower are largely unchanged. The furnace, which is listed on the National Register of Historic Places, was Oregon's largest manufacturing enterprise in the 19th century and produced pig iron for foundries in Portland and San Francisco.

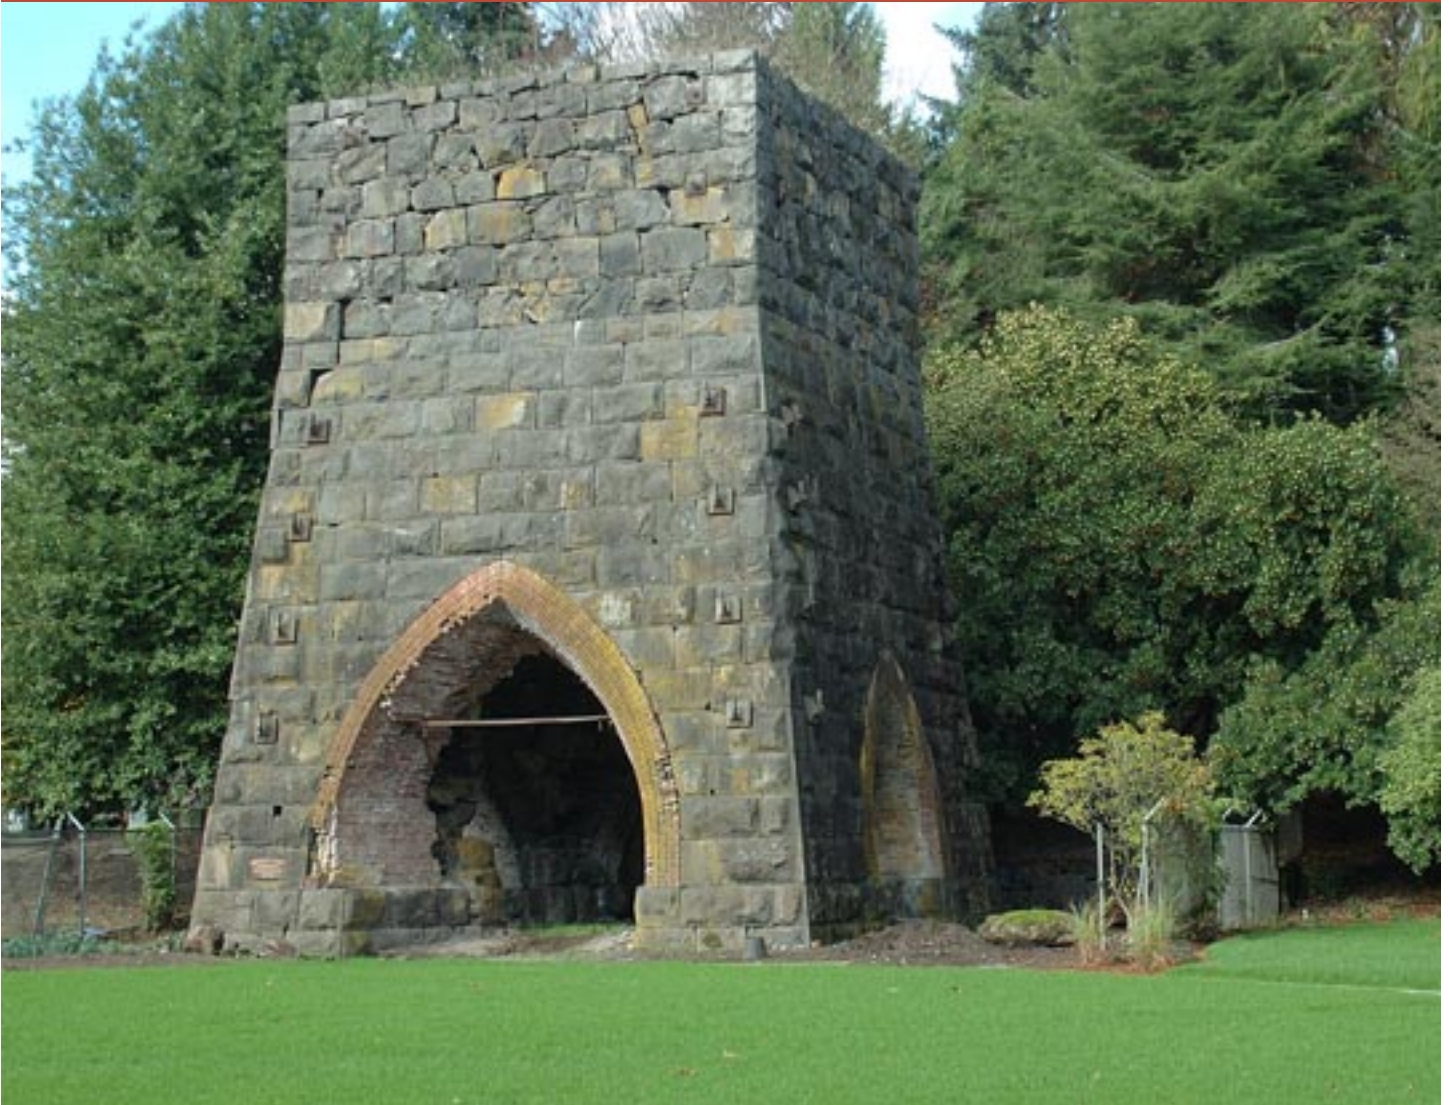
The Casting Arch has suffered the most damage to its brickwork.

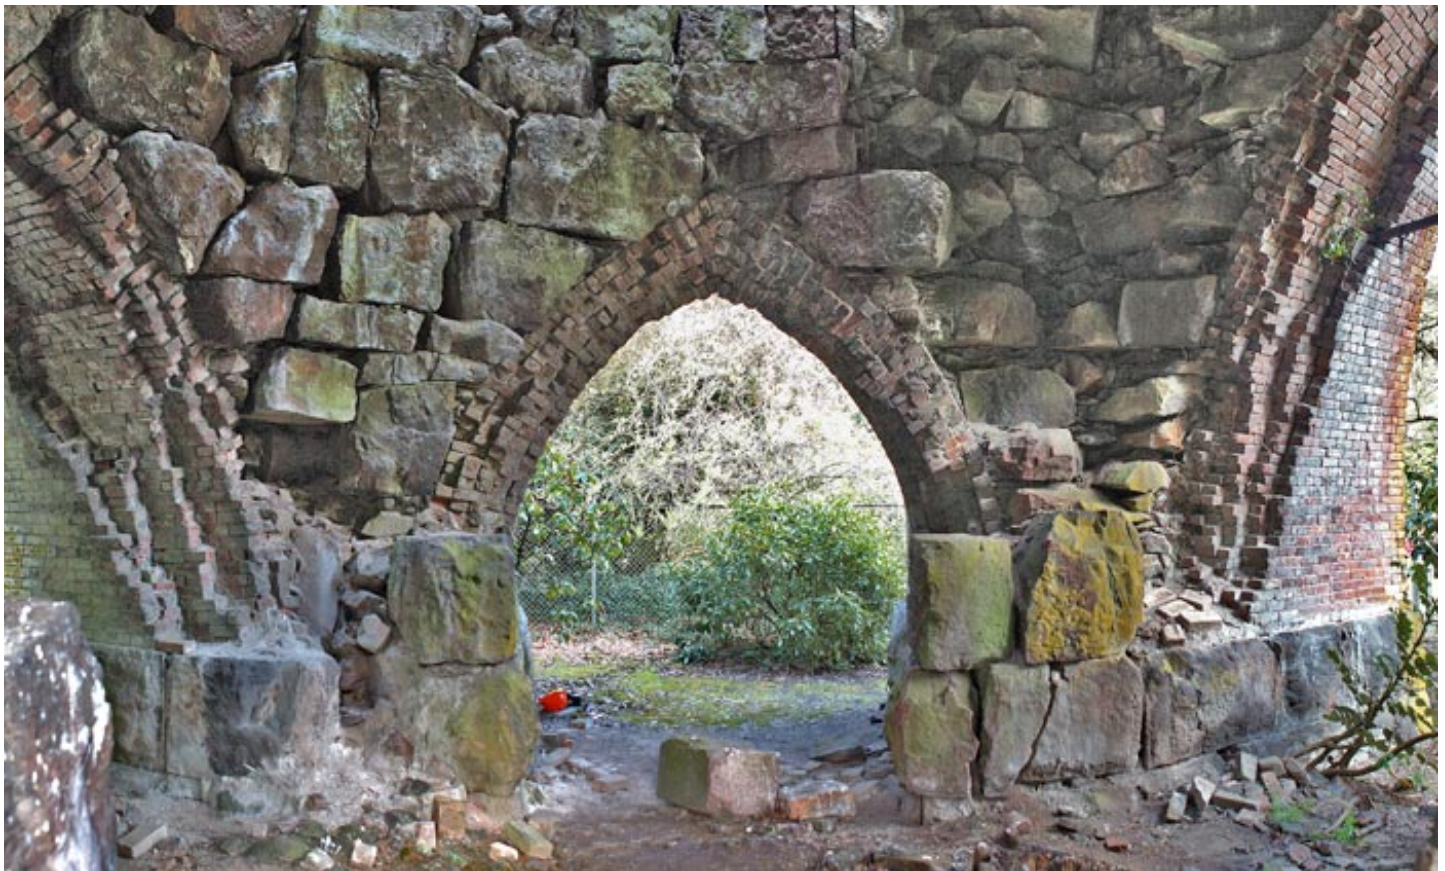
Panoramic view of the interior shows where large blocks have fallen and exposed the rubble fill between the inner and outer walls. *Photo/Frank and Susanna Kuo*

1. Rebuild missing stonework with matching basalt.
2. Grout the masonry with natural hydraulic lime mortar approved for historic preservation.
3. Rebuild the brick arches.
4. Inject grout into the rubble fill between the inner and outer walls.
5. Anchor the stack to its foundation with four vertical steel rods.
6. Install a low profile soldered seam lead roof for weather protection.
7. Install recessed iron gates in the four arches.
